## ***NIST Technical Note 1426***

# ***The Fujita Tornado Intensity Scale: A Critique Based on Observations of the Jarrell Tornado of May 27, 1997***

***Long T. Phan and Emil Simiu***

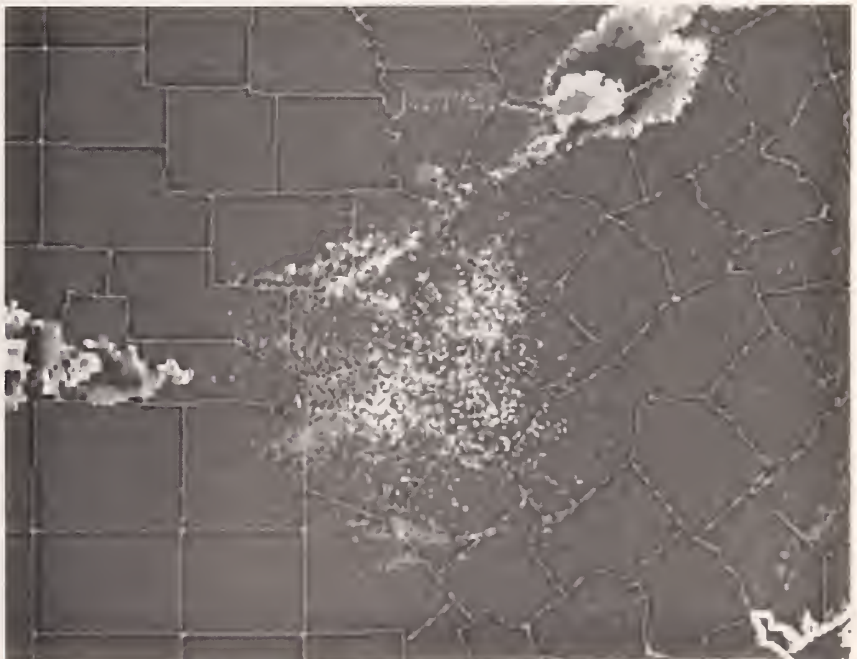
Figure 2b. Radar reflectivity image of the thunderstorm that produced the Jarrell tornado (picture from NOAA SPC web site).

Shortly before 3:40 P.M. (CDT), tornado sirens were sounded alerting residents in Jarrell of tornado sightings. Shortly before 3:45 P.M. (CDT), the most violent of all tornadoes that were spawned on May 27, 1997, now known as the Jarrell tornado, first struck areas of Bell County and then crossed into Williamson County. The city of Jarrell suffered 27 confirmed deaths and more than 40 structures were destroyed, including single-family homes, a commercial light steel frame structure, and several mobile homes. Most of the deaths and structural damage occurred in Jarrell's Double Creek Estates subdivision. Images of the thunderstorm that produced this tornado were captured by the NOAA GOES-8 satellite and the Austin, Texas WSR-88D radar site (see figs. 2a and 2b).

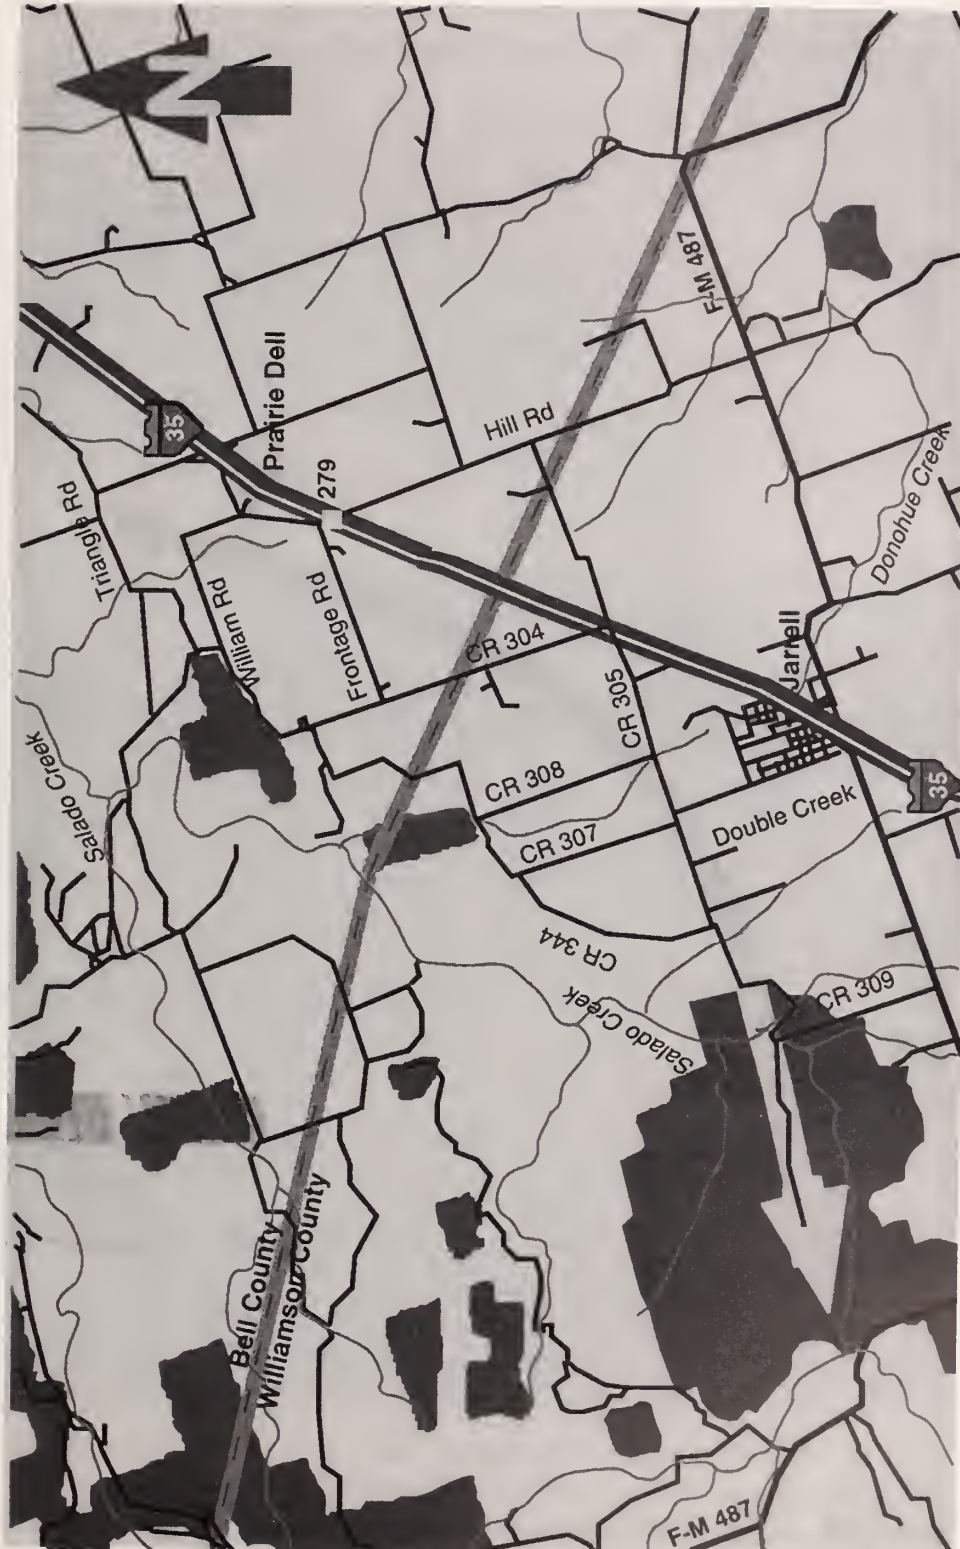
Figure 3. Jarrell tornado path.

Figure 3 shows the path of the Jarrell tornado, based on information obtained in the OFCM damage survey. The path began in Bell County at a point about 1.3 km northwest of the Prairie Dell exit from Interstate 35 (coordinates 30° 53.90' N/97° 35.20' W). The tornado tracked southwestward, almost parallel to Interstate 35, then crossed the Bell/Williamson County line where it assumed a more westerly course. The tornado path ended in a heavily wooded area southwest of Jarrell in Williamson County (coordinates 30° 49.18' N/97° 40.12' W). Based on the information from the GPS, the path length of the tornado was estimated to be 12.2 km (7.6 mi), of which 3.9 km (2.4 mi) was in Bell County and 8.3 km (5.2 mi) was in Williamson County. The Double Creek Estates subdivision was located in open terrain, slightly rolling, with few trees. The tornado's maximum path width was measured in that subdivision to be approximately 1.2 km (0.75 mi). Witnesses estimated that its translational speed was between 8 km/hr and 16 km/hr (5 mph to 10 mph).

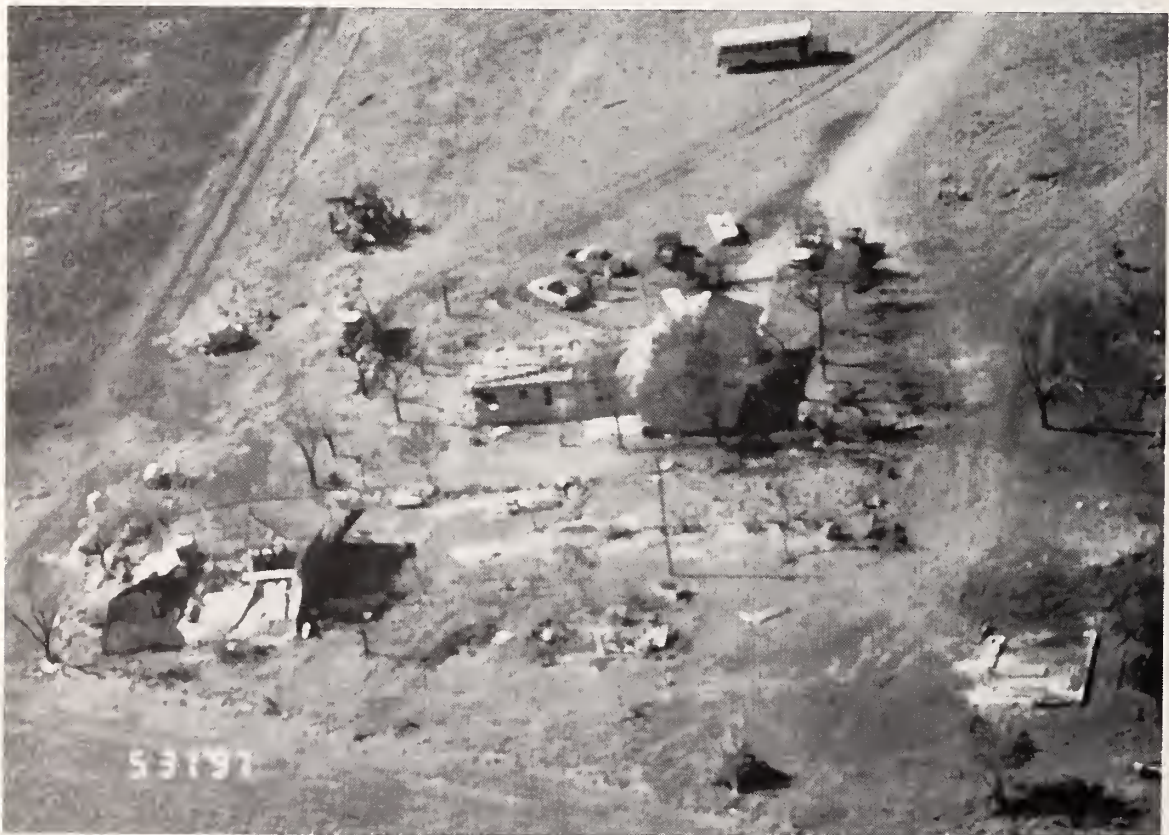
Figure 4. Damage to roof of residences in Bell County at the beginning of the Jarrell tornado track.

Damage began in open terrain in Bell County and was limited primarily to trees and the roofs of a few residential structures (see fig. 4). The tornado then crossed the Bell/Williamson County line and moved across County Road (CR) 308, CR 305, and CR 307. The locations where the tornado crossed these roadways were clearly marked by strips of scoured asphalt road surface (see fig. 5), typically as wide as the road and with lengths of 1.5 m (5 ft) to more than 100 m (330 ft). The top layer of the asphalt pavement was approximately 20 mm (0.8 in) thick. We ascribe the scouring of the asphalt to differences between the atmospheric pressure of pockets of air trapped underneath the asphalt and the lower atmospheric pressure at the center of the tornado.

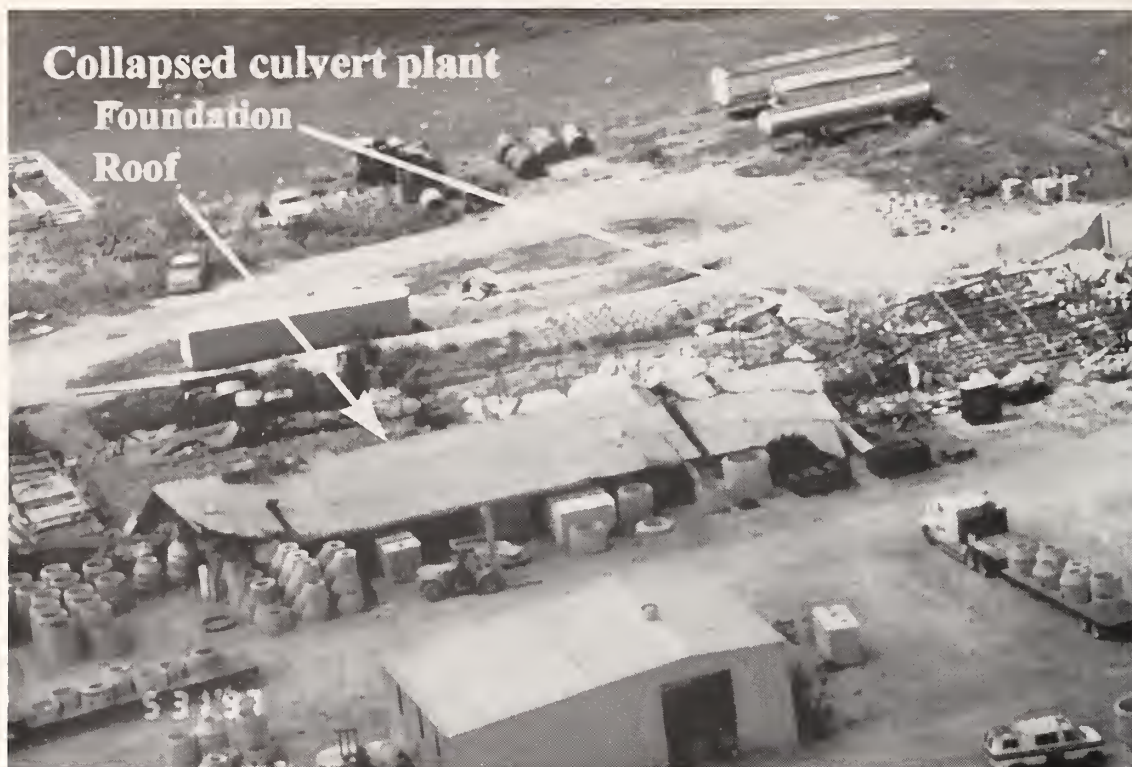
Figure 6. Aerial view of collapsed culvert plant.

The next structural damage along the tornado path occurred at the corner of CR 305 and CR 307 in Williamson County, where a culvert plant collapsed (figs. 6 to 8). The plant was of light steel frame construction with non-reinforced masonry and steel tube columns supporting steel pipe, gable roof trusses. The steel tube columns were cast into a concrete mat foundation on grade. The roofing, supported by wood purlins, consisted of corrugated sheet metal. An identical plant approximately 15 m (50 ft) away from the collapsed culvert plant, and other surrounding structures, suffered only minimal damage (fig. 8). A mobile home used as an office was hit by a conventional “two by four” timber member 1.2 m (4 ft) long, but the missile did not penetrate into the home. A mobile home located about 150 m (500 ft) north-northwest of the plant had only minor damage. Its occupants fled to a house that was in the center of the damage path, where they were reportedly killed.

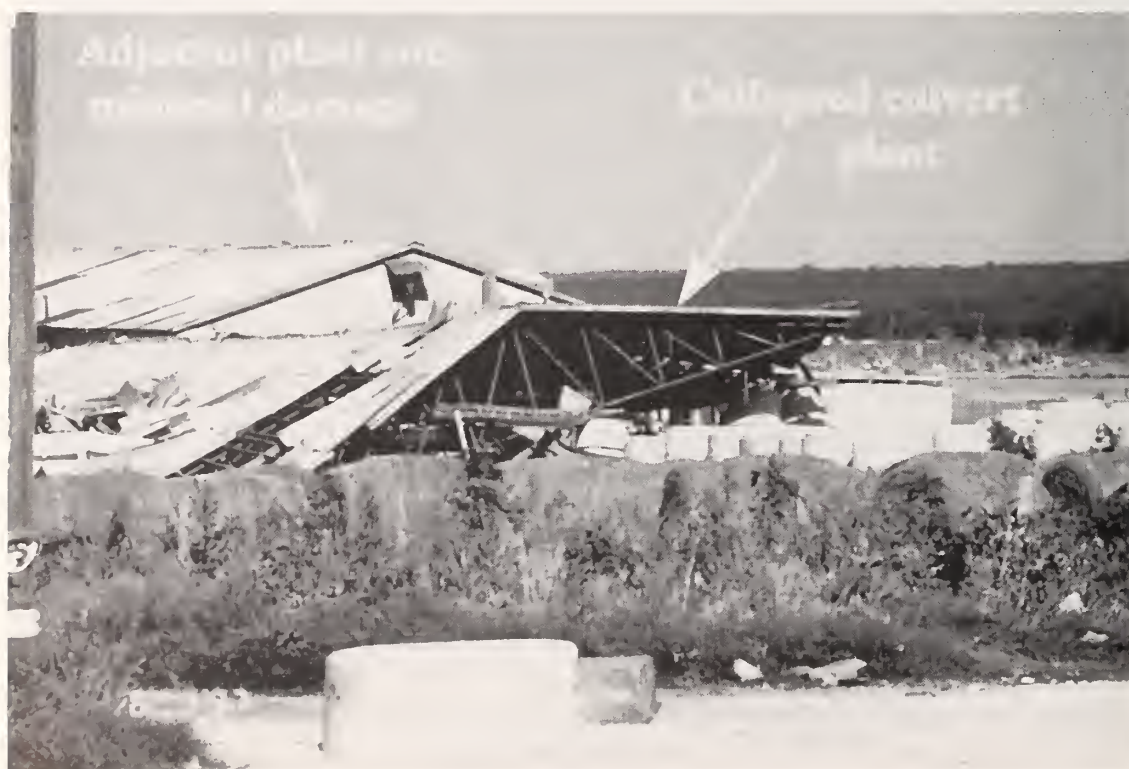
Figure 7. Ground view of collapsed culvert plant.

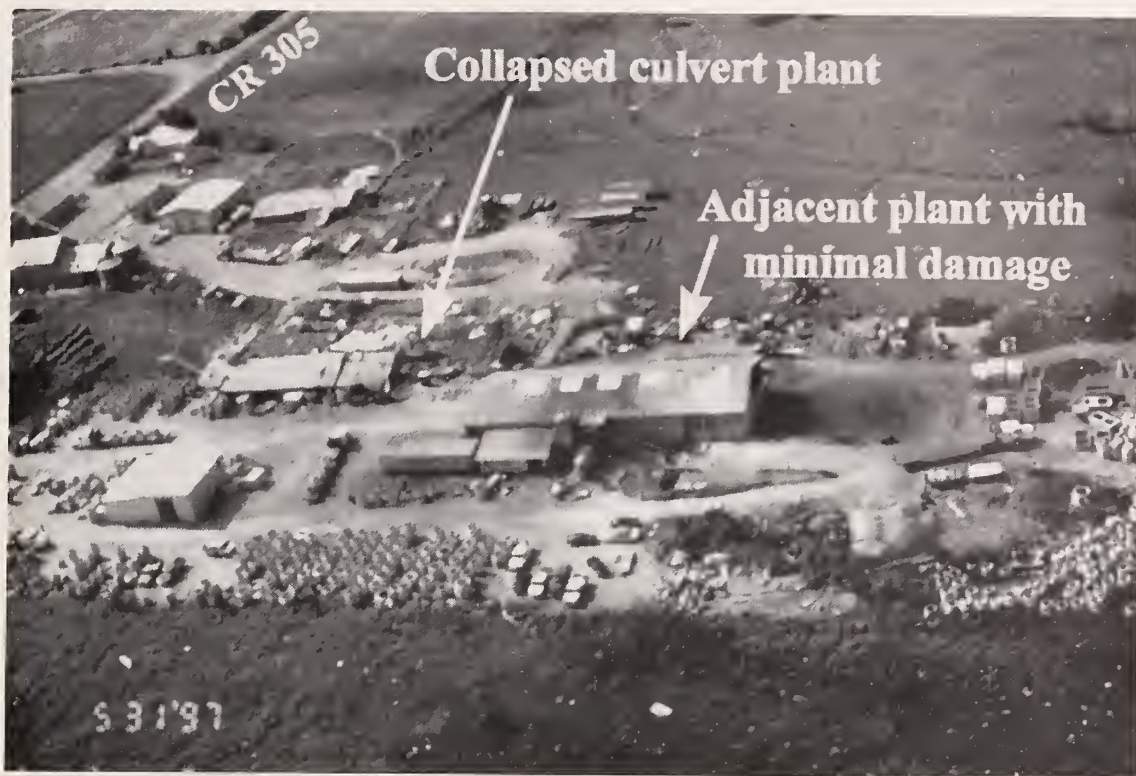
Figure 8. Aerial view of entire culvert plant complex.

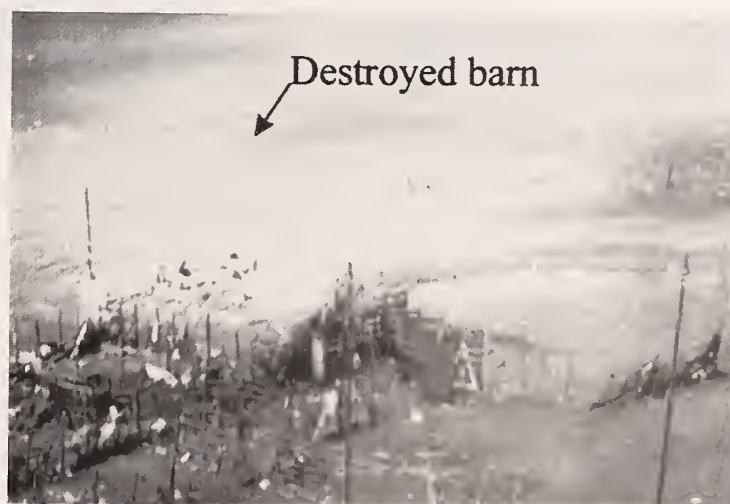
Figure 9. Destroyed barn located between culvert plant complex and Double Creek Estates subdivision.

As the tornado continued its track south southwestward, a barn located just southwest of the culvert plant and just north of the Double Creek Estates subdivision was destroyed (fig. 9). The tornado then moved through the Double Creek Estates subdivision and the surrounding areas, where the destructive path widened to its maximum of 1.2 km (0.75 mi) and the tornado became most deadly.

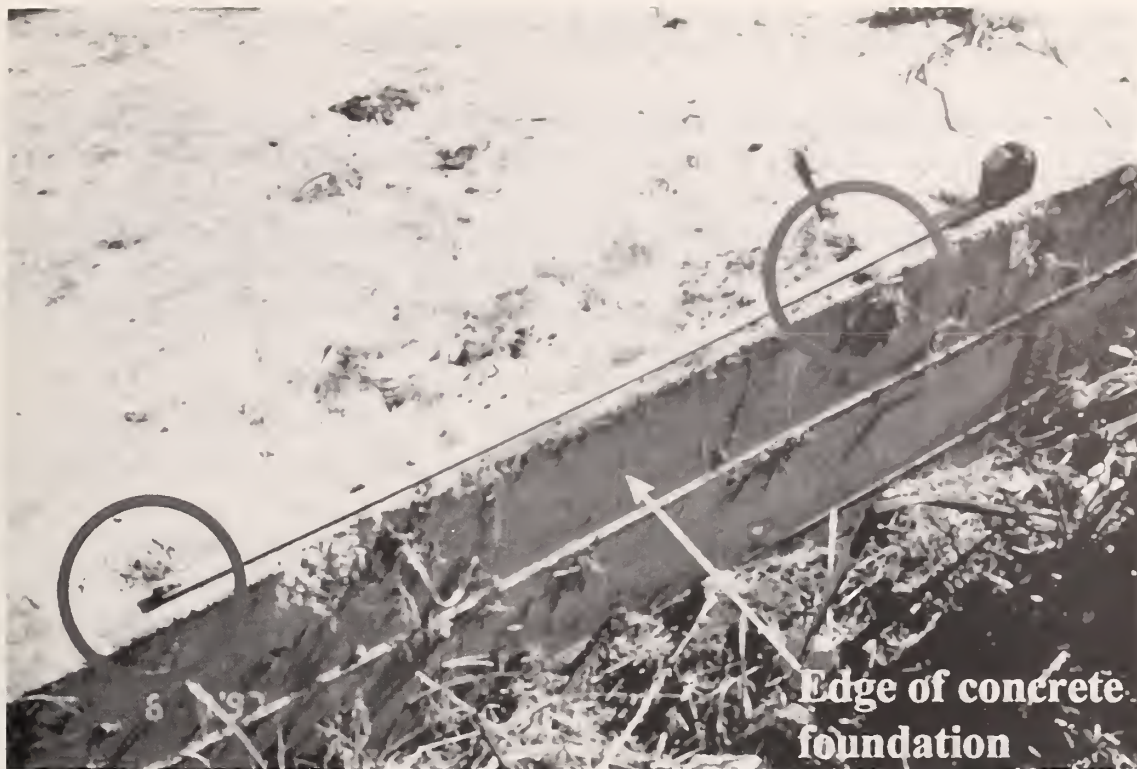
Figure 13. Evidence of pullout of nails used to fasten sill plates to concrete foundation.

Inspections of the concrete slab-on-grade foundations performed during the ground surveys revealed that, in many cases, even the sill plates that connected the wood frames to the concrete foundations were blown away (see fig. 11). This suggests that the connections between the sill plates and the foundations were not as strong as those between the sill plate and the wood frames. Random, close examination of a few concrete foundations suggested that the houses in this subdivision may not have been well built. For some houses, there was evidence that the sill plates had been connected to the foundations by nails. Figure 12 shows a nail that remained in the foundation, but pulled through the sill plate. Figure 13 shows examples where the nails, which appeared to have been spaced 0.9 m (3 ft) apart, pulled out of the foundation. There was no evidence of anchor bolts or steel straps used at the few random foundations where close inspections were performed. We note

that the Council of American Building Officials (CABO) One and Two-Family Dwelling Code (1995) requires that sill plates of exterior walls for wood-frame construction be anchored to the concrete foundation by 13 mm-diameter (1/2-inch) anchor bolts not more than 1.83 m apart and less than 0.31 m from corners. We also note that Williamson County has not adopted a building code, even though Jarrell had been hit by a tornado on May 17, 1987.

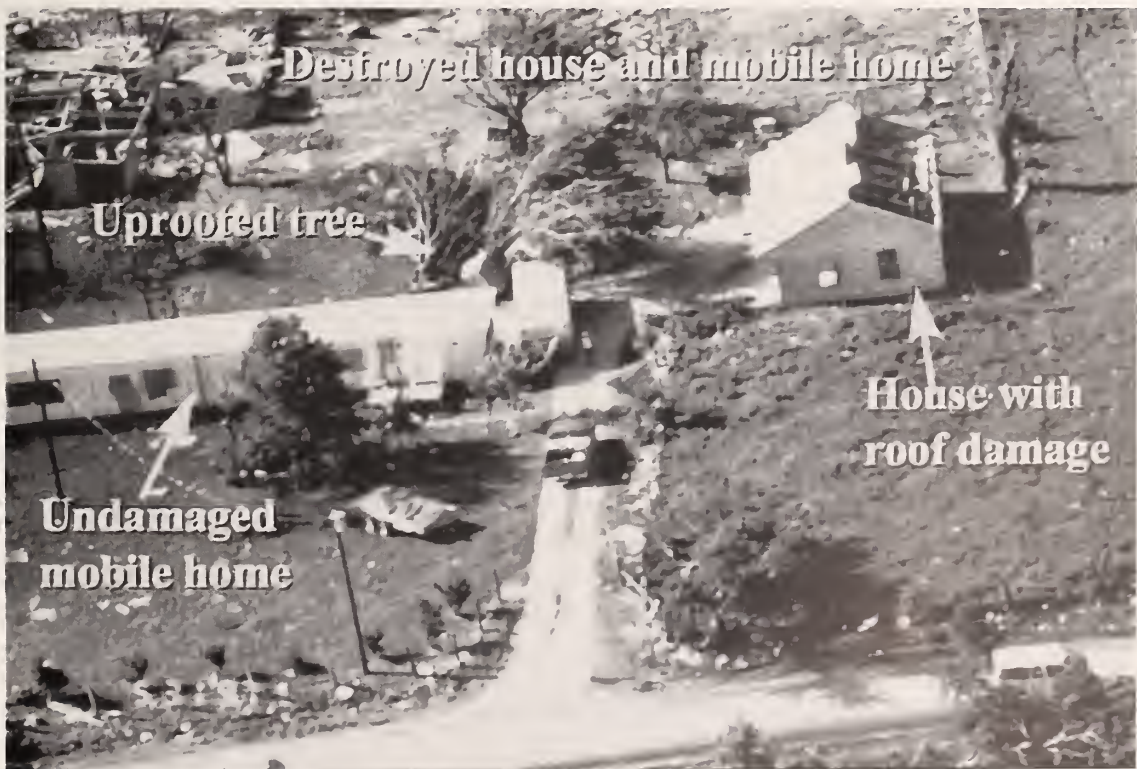
Figure 14. Structural damage near the end of the path of the Jarrel tornado.

The path of destruction narrowed as the tornado moved to the outlying areas of the Double Creek Estates subdivision. Here the destruction became random. Figure 14 shows a mobile home that sustained only minor damage, while a short distance away a large tree was uprooted and another house lost half of its roof. The tornado then moved across CR 309 and ended in a heavily wooded area southwest of Jarrell.
